Technical Service Bulletin

MIL on (DTC P310B and/or P129F)

24 08 12 2015106/4 March 3, 2008. Supersedes Technical Service Bulletin Group 24 number 07-19 dated Nov. 19, 2007 to revise affected engines.

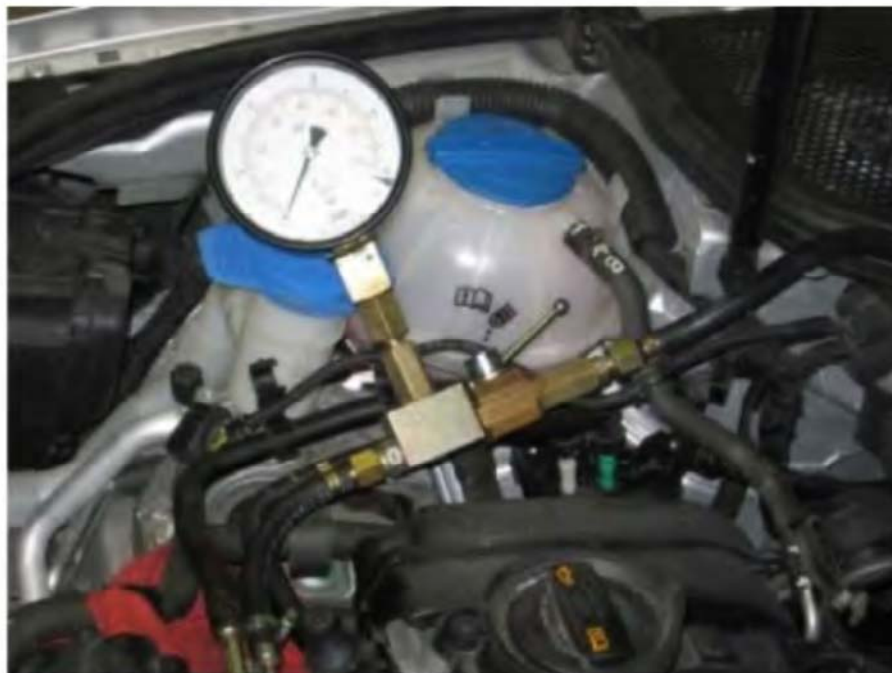
5. Measure actual low-side fuel pressure via mechanical gauge (VAG 1318) on the low pressure supply line in the engine compartment (Figure 1).

Figure 1. VAG 1318 gauge installed on an A3 2.0L TFSI vehicle.

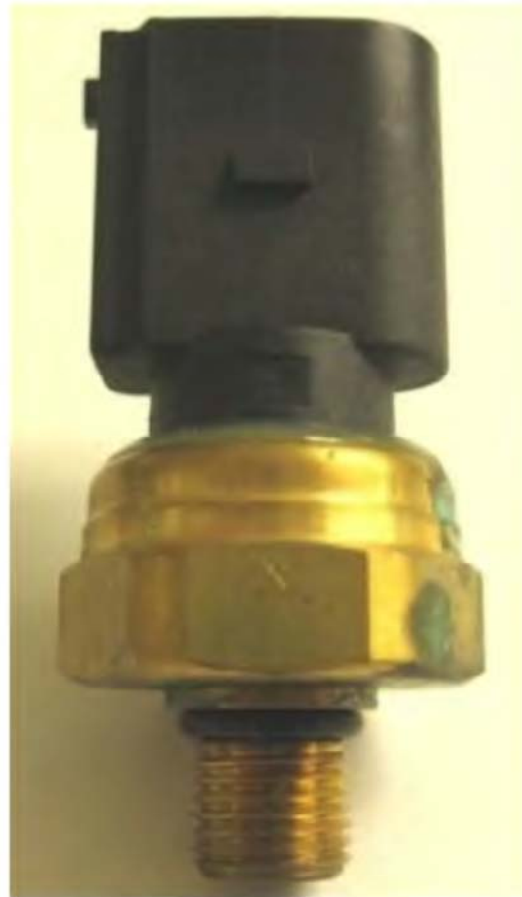
Due to fuel intrusion into the low-pressure system fuel pressure sensor (G410), a false signal may be sent to the controller, resulting in a reading that is out of tolerance.

Figure 2. Fuel pressure sensor 06E 906 051 K.

1. Replace the G410 low-side fuel pressure sensor.

2. Clear DTCs and verify that the problem was eliminated.
3. Run Basic Settings 103 to adapt system.
4. Do not replace fuel pump, fuel pump control module, or fuel filter unless problem persists.
